**DELAWARE RIVER BASIN  
LOWER BIRCHWOOD LAKE DAM**

NDI NO. PA-00403  
DER NO. 52-145

**PHASE I INSPECTION REPORT  
NATIONAL DAM INSPECTION PROGRAM**

BY  
Berger Associates, Inc.  
Harrisburg, Pennsylvania  
JUNE 1980

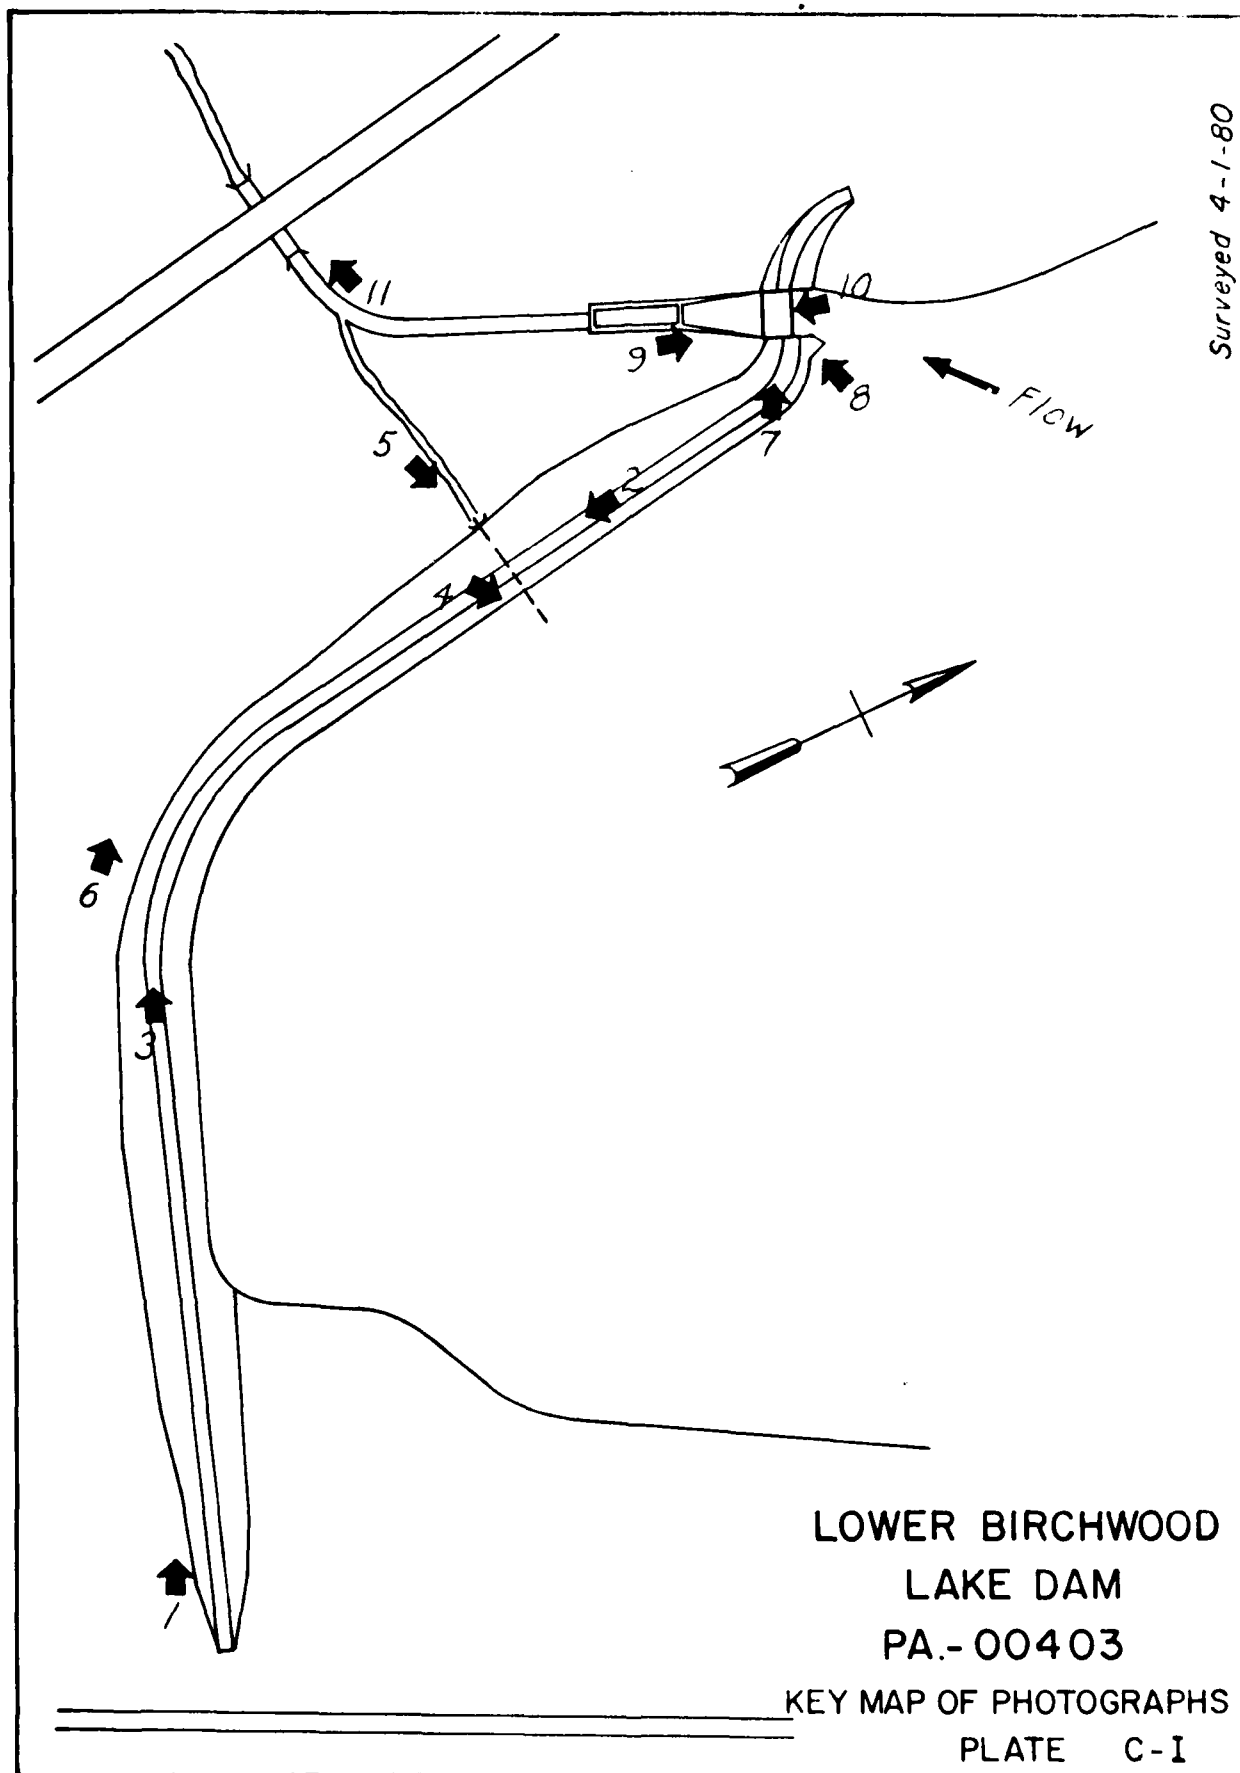
The upstream slope is protected by dumped riprap to the crest elevation of the dam. The upstream slope has a heavy growth of Birch trees over the full length of the dam (see Photographs No. 2, 3 & 4, Appendix C). This growth is considered undesirable for an earthfill dam. Some erosion of the upstream slope has occurred immediately adjacent to both sides of the spillway (Photograph No. 7). Although cutoff walls are preventing further erosion, it is recommended to place fill in these areas.

CREST OF DAM - NO. 2  
NOTE: TREES AND BRUSH
